# Lake Superior Shoreline Recession Analysis using Historic Aerial Photography

Mark Miller Benchmark GIS

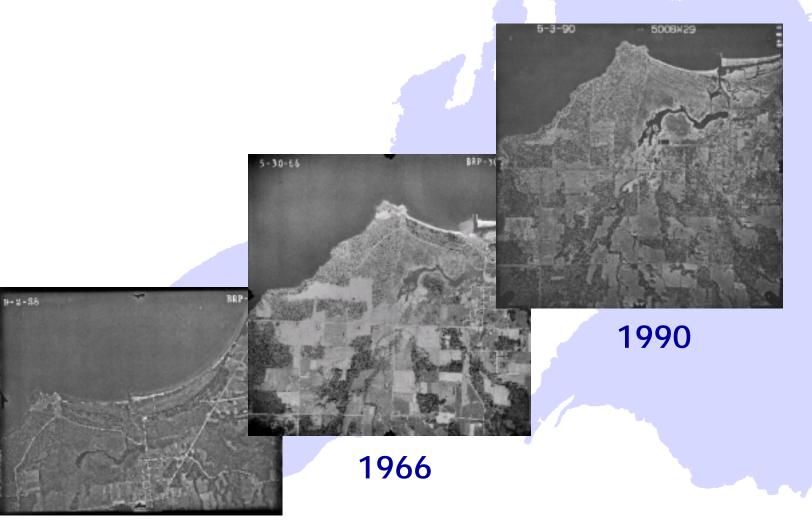
1938

# Historic Aerial Imagery

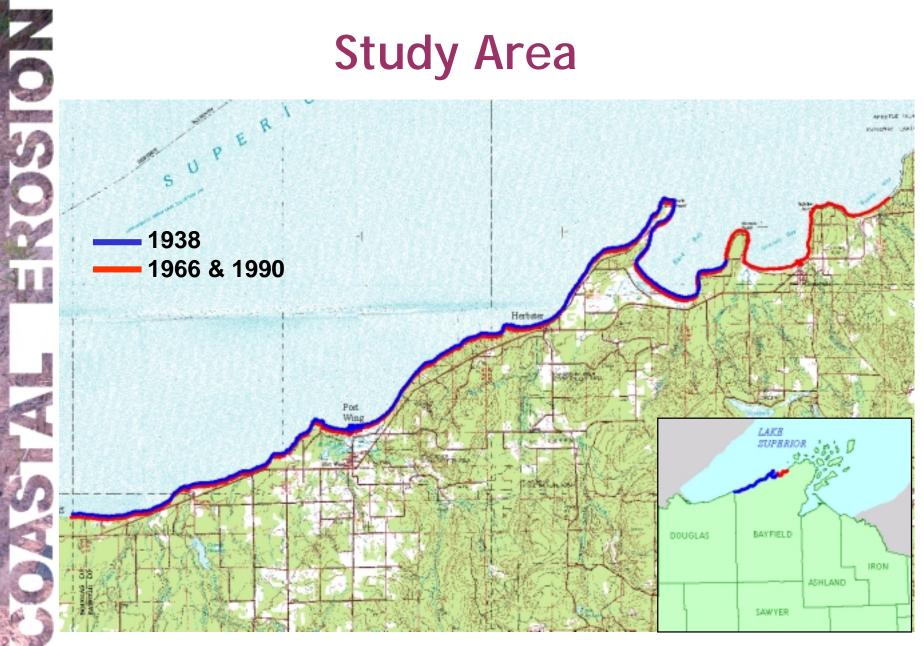
# **Study Area**

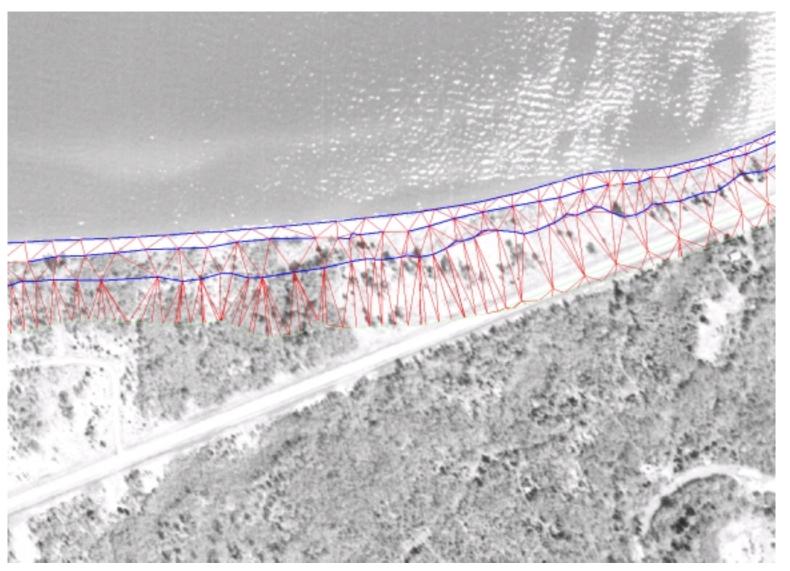
## 3D Shoreline Delineation

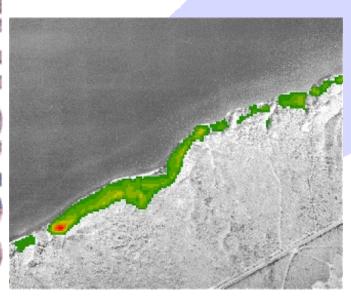
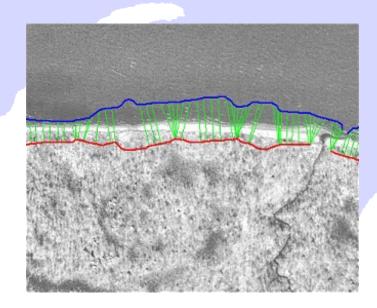
Two analyses performed to evaluate the potential of derived products:

- Volumetric analysis
- Ridge recession analysis

- Subtract terrain models from each other
- Each 10-meter cell (pixel) represents 100 square meters; a 1-meter difference in height = 100 cubic meters
- For 28 mile stretch (1938-1990) :
  - 4 million cubic meters lost
  - 77,000 cubic meters per year
  - 2,800 cubic meters per mile per year

- Software written to calculate distance between bluff lines
- Provides measure of change along entire shore
- Most extreme measure between 1938 and 1990: 57 meters, or 1.1 meters per year

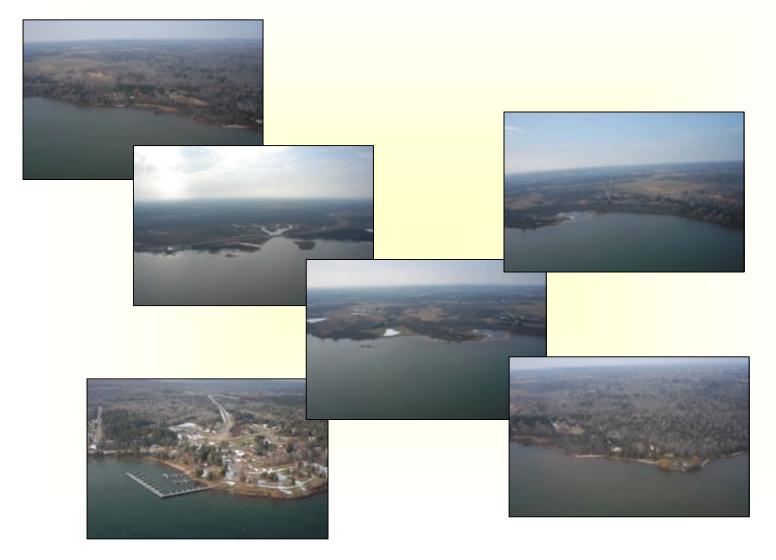
# **Oblique Shoreline Imagery**

- 513 photos (Fish Creek to Brule River), November 2002
- High Resolution images 2240 x 1488
- GPS used to record camera position
- Employed the expertise of Bad River Natural Resources personnel
- Created "ShoreViewer" on Land Records website: http://www.bayfieldcounty.org/LandRecords/ shoreviewer\_start.htm
- Created "Lake Superior Shore Profile Analysis" on Land Records website:

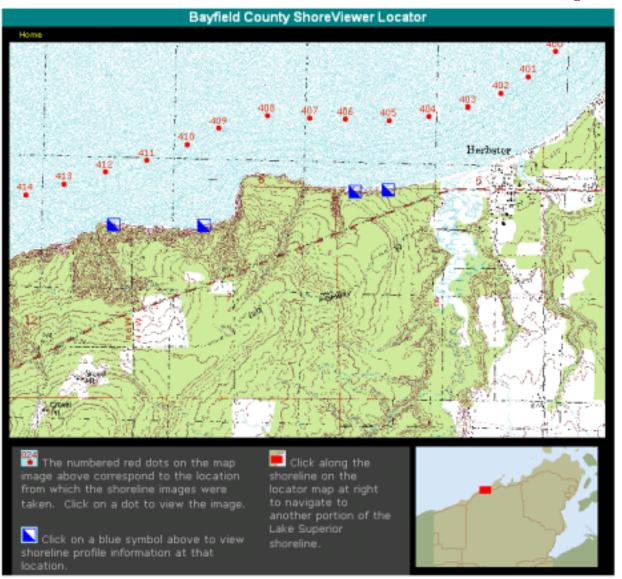
# **ShoreViewer Locator Map**

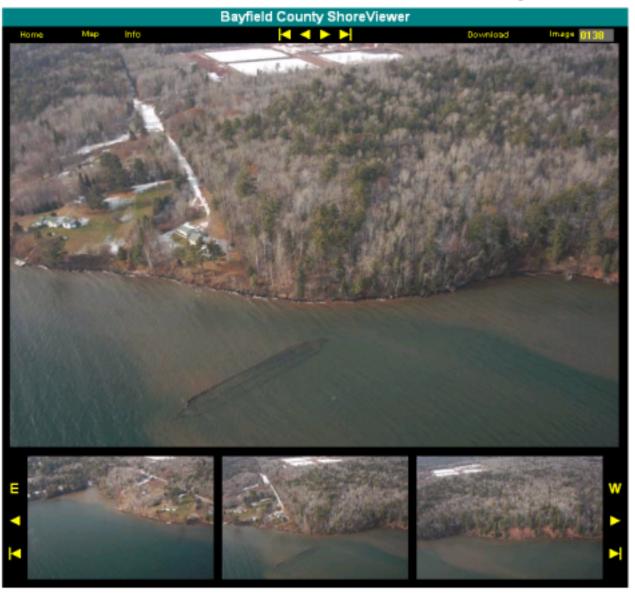
# **Example Oblique Photograph**

Close range, oblique aerial photographs taken of the entire Bayfield County shoreline in the Fall of 2002. These photos serve as a visual baseline of the shoreline condition and can be used for a variety of educational and planning activities.
